Manhole Inspection Summary

Manhole # S09WW1005MH

Insp Date: **8/1/06 8:40 AM**

Location Address: **2608 KEN OAK RD**

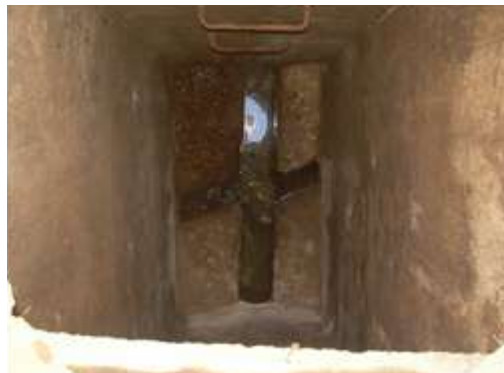
Top View

Corroded steps. Bench and Channel debris.

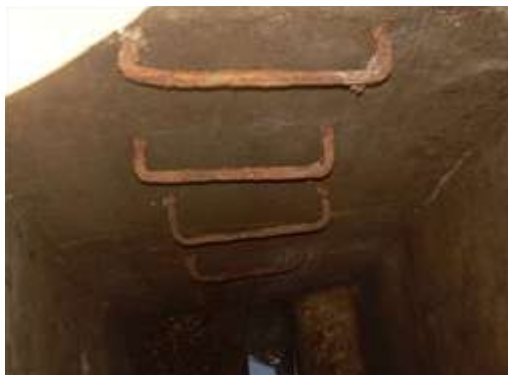
Defect

☒ **Corroded**

Corroded steps.

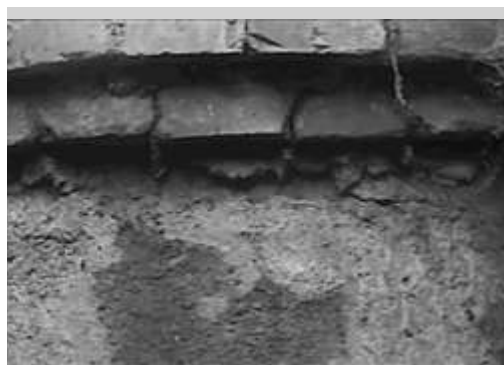
Defect

Condition: ☐ Sound ☐ Cracked ☐ Root Intrusion ☐ Loose Brick ☒ **Deteriorated**

Infiltration: ☐ None ☒ **Joint** ☐ Cracks ☒ **Mortar** ☐ Roots ☐ Wall

Corbel deterioration and infiltration.

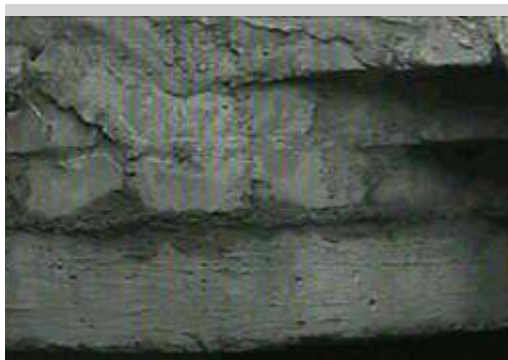
Defect

Corbel infiltration.

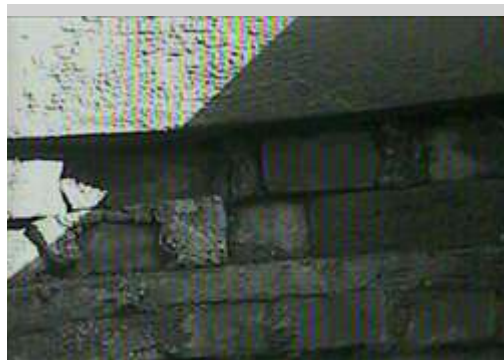
Defect

☒ **Leaks**

Condition: ☐ Sound ☐ Cracked ☐ Root Intrusion ☐ Loose Brick ☒ **Deteriorated**

Infiltration: ☐ None ☒ **Joint** ☐ Cracks ☒ **Mortar** ☐ Roots ☐ Wall

Frame leaks. Adjustment deterioration and infiltration.

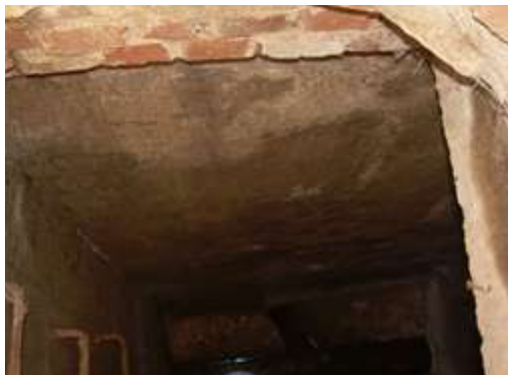
Defect

Infiltration: ☐ None ☐ Joint ☐ Cracks ☐ Mortar ☐ Roots ☒ **Wall**

Barrel infiltration.

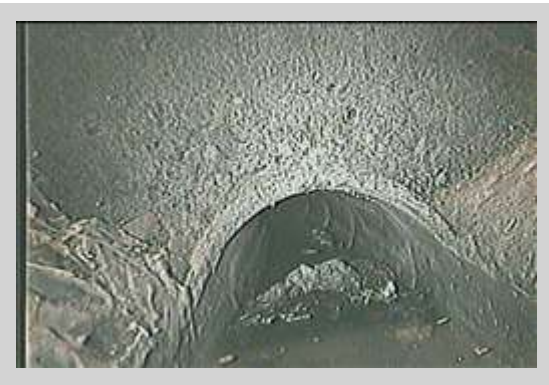
8 in. Circular Gravity Sewer Pipe Out @ 12 O'Clock

Deposits: ☐ None ☒ **Mud** ☐ Sludge ☒ **Debris** ☐ Grease

Silt Depth: **0.5** (in.) Deposits Extent: **Light**

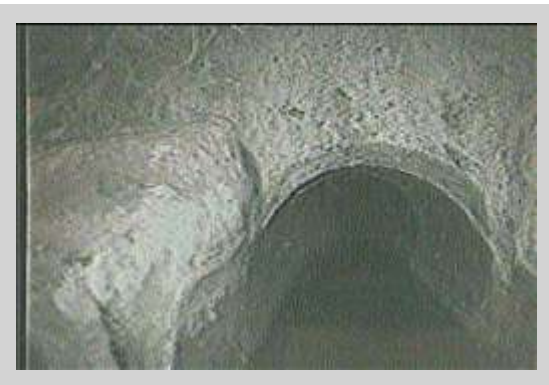
6 in. Circular Gravity Sewer Pipe In @ 3 O'Clock

Barrel root intrusion.

Infiltration: **Evidence** Pipe Seal Cond: **Unknown**

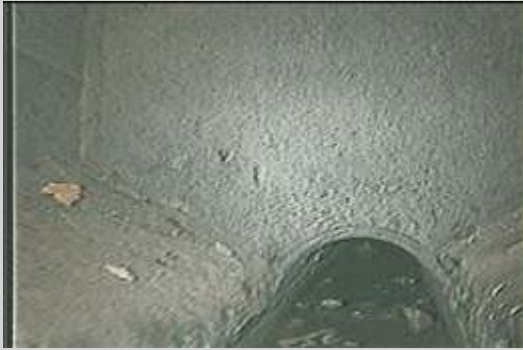
Pipe In @ 6 O'Clock

Deposits: ☐ None ☒ **Mud** ☐ Sludge ☒ **Debris** ☐ Grease

Silt Depth: **1** (in.) Deposits Extent: **Medium**
